Prepared for:
BASF Corporation
Toms River, NJ

Prepared by:
AECOM
Chelmsford, MA
60330182
April 2016

FINAL Corrective Measures Study

BASF Corporation
Former Ciba-Geigy Facility
180 Mill Street
Cranston, Rhode Island

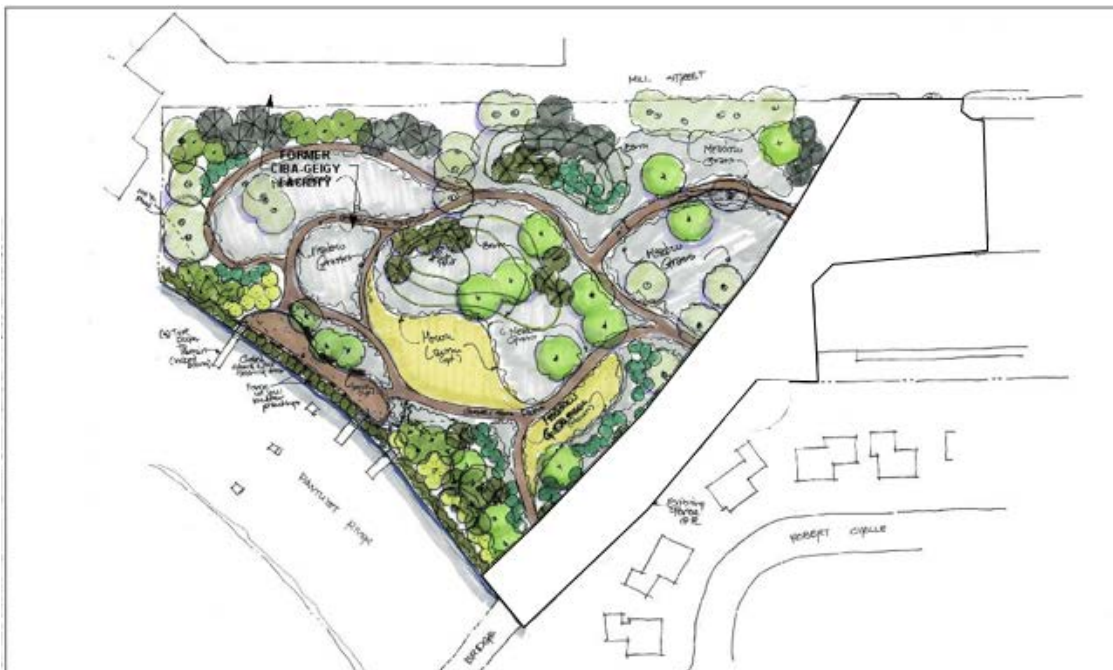
Inset Figure 1 – Conceptual regrading and native habitat enhancement plan associated with the FPA high-occupancy cover remedy and open space/parkland reuse.

Figure 18A and Figure 18B show two conceptual scenarios of the proposed excavation and extent of the high-occupancy cover, and Inset Figure 1 provides a conceptual regrading and native habitat enhancement plan associated with the FPA high occupancy cover remedy.

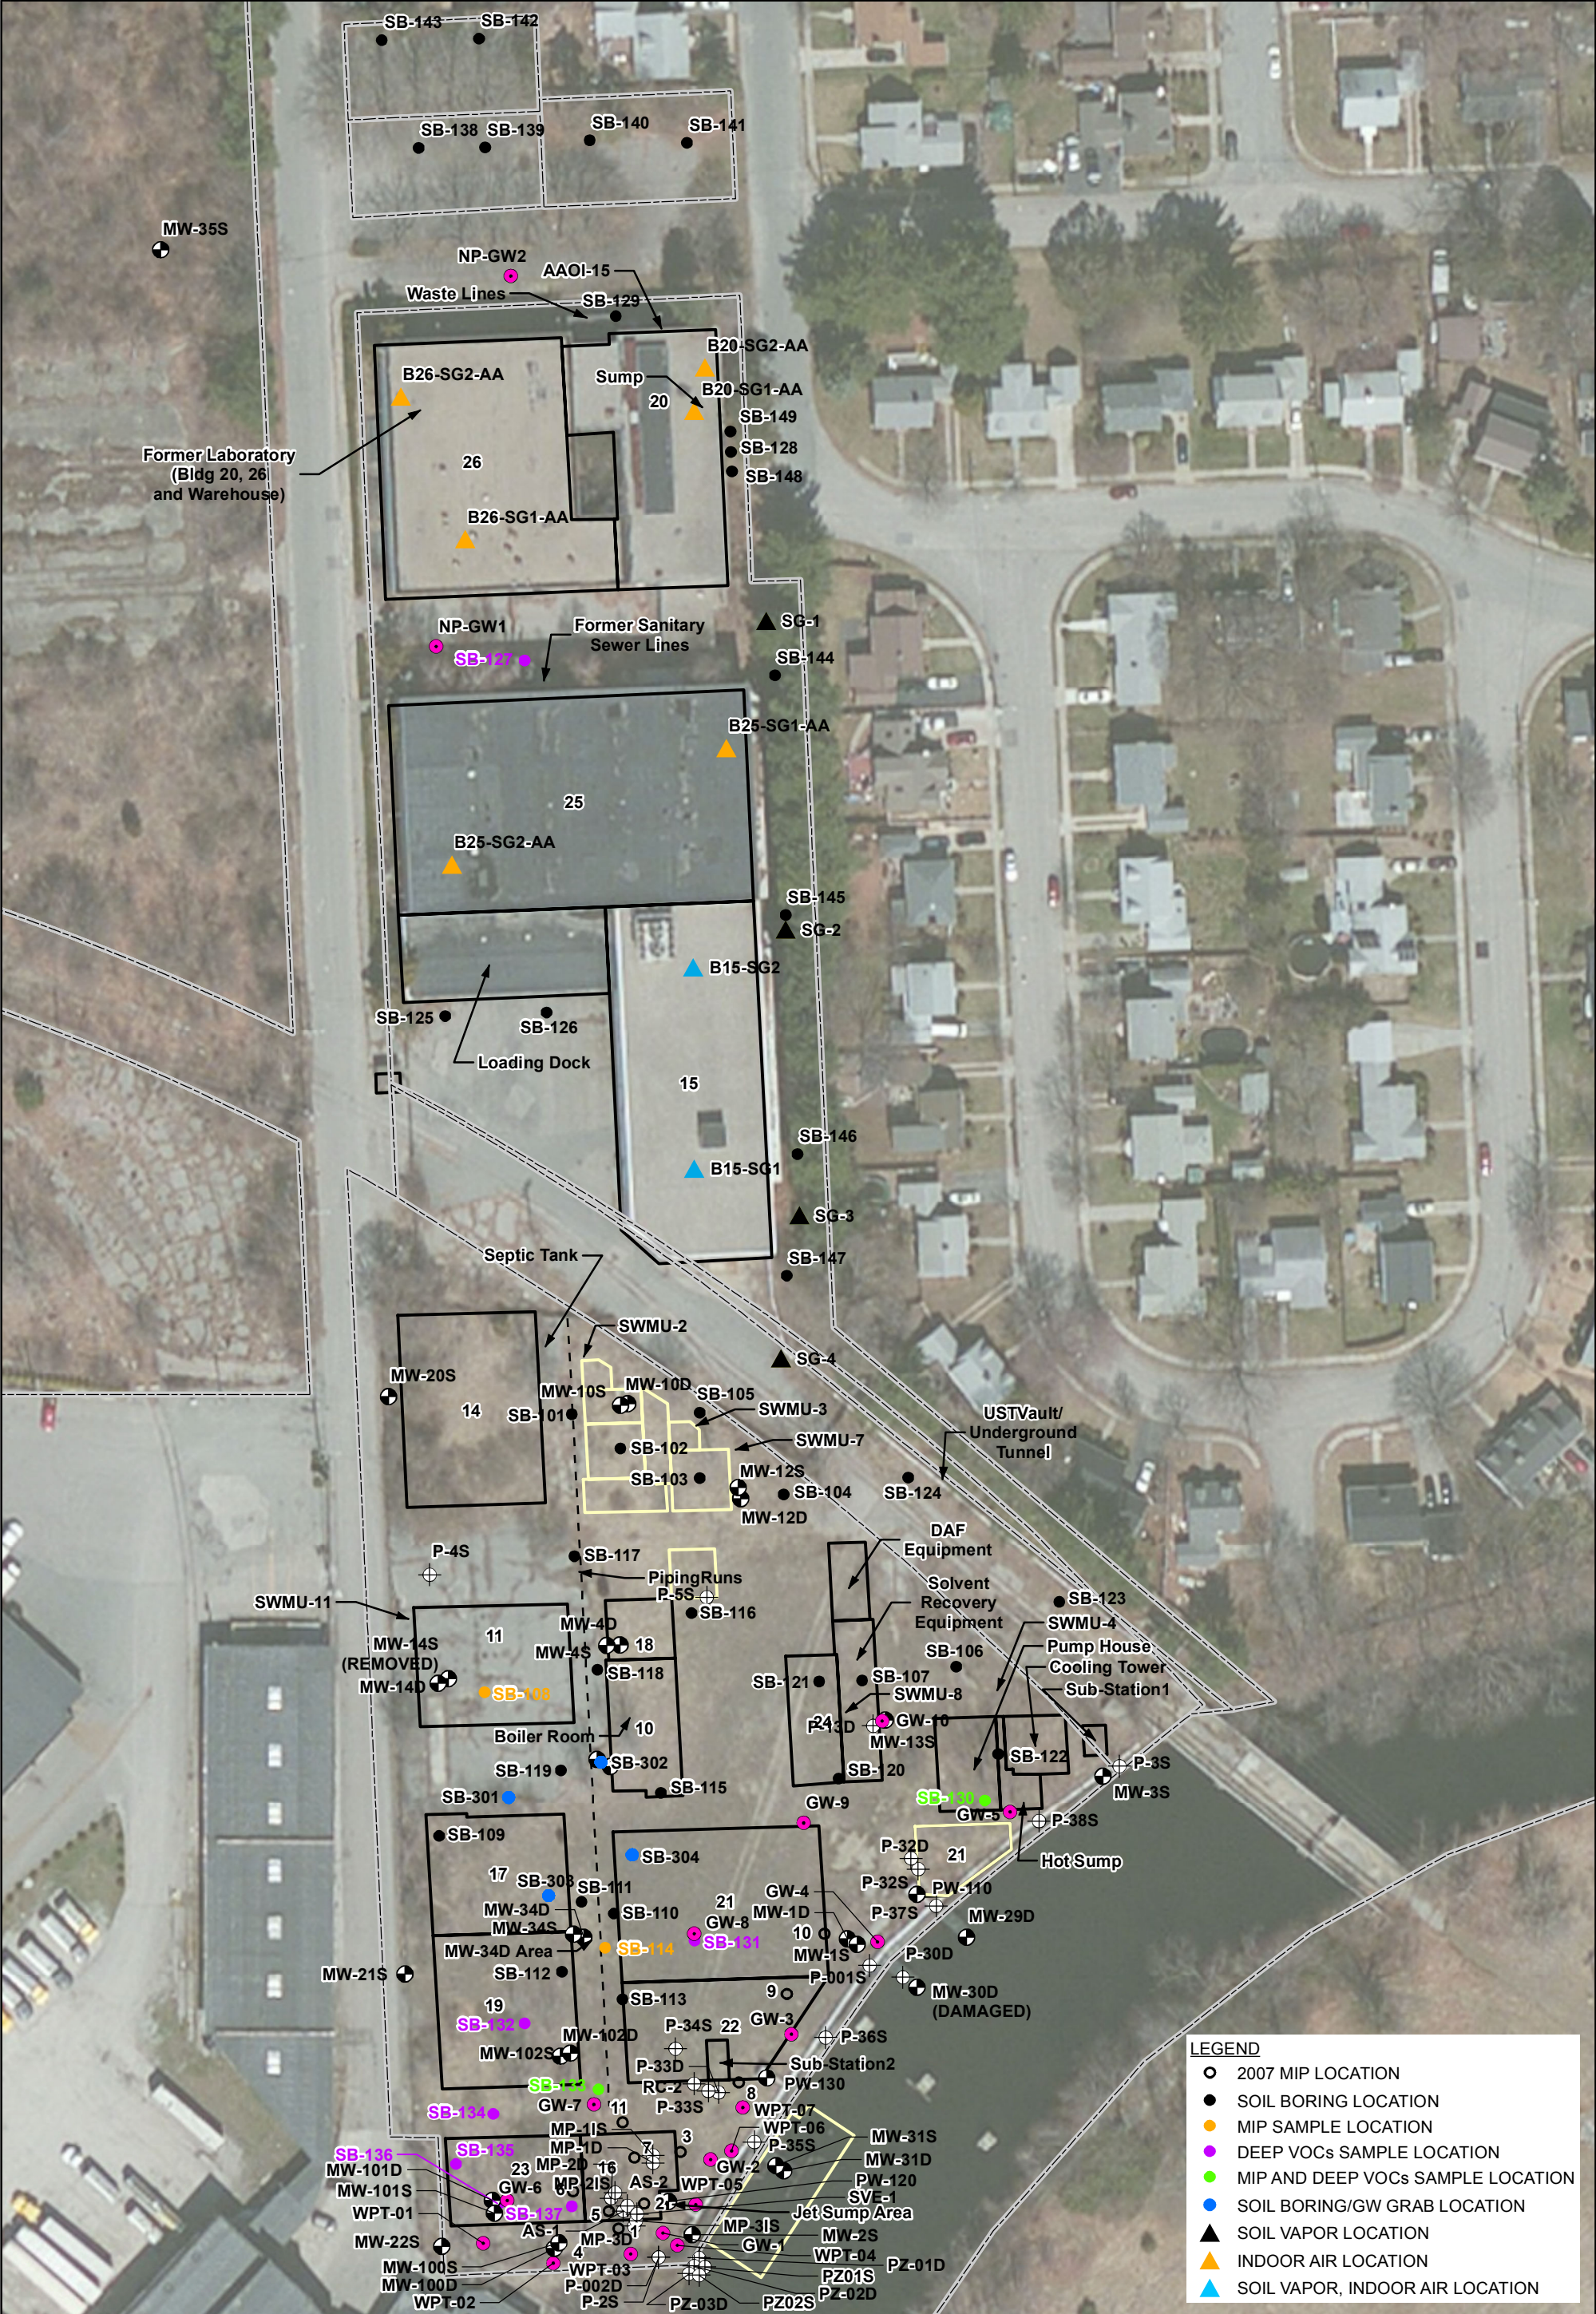
FIGURE 6

PRODUCTION AREA INVESTIGATION LOCATIONS
GROUNDWATER, SOIL AND SOIL GAS
CORRECTIVE MEASURES STUDY
